Damage to engineered structures during the 12 January 2010, Haiti (Léogâne) earthquake¹

Patrick Paultre, Éric Calais, Jean Proulx, Claude Prépetit, and Steeve Ambroise

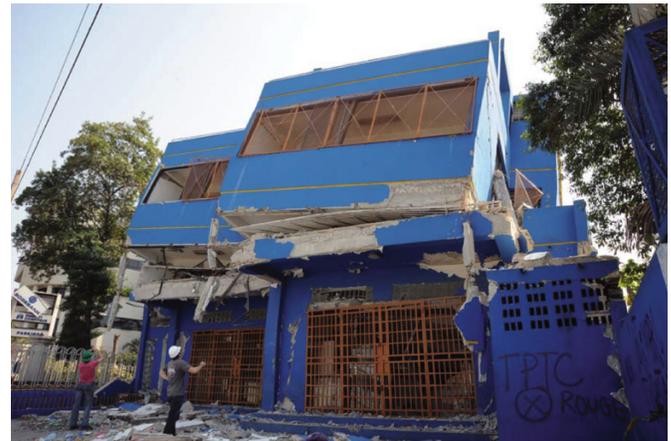
Fig. 3. Failure of a three-story building with crushing of the second soft/weak storey. (photo: P. Paultre).

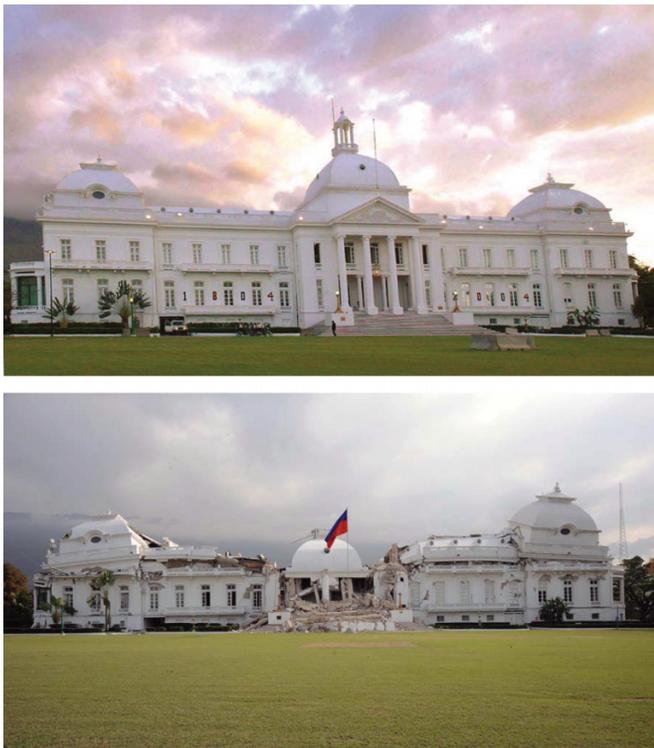
Fig. 6. The *Palais National*, top photo before the earthquake (photo J. Raedle, Getty Images) and, bottom photo after the earthquake (photo, P. Paultre).

The *Palais National*, the presidential residence, is the most well-known landmark building in Port-Au-Prince. Built between 1913 and 1921, it was designed by Georges Baussan, one of the three architects that developed the gingerbread style houses in Port-Au-Prince. This building was designed by the French Hennebique firm in the early period of the development of reinforced concrete as a construction material. The reinforcement materials are surprisingly varied in form, due to the fact that the construction took place in part during the First World War and that the materials had to be purchased sometimes on the black market (Corvington et al. 2003). It is a moment-resisting frame system with infill unreinforced brick masonry, as well as infill rubble walls. Some infill walls are covered with what appear to be reinforced concrete walls that might have been added later and explained why the building did not collapse entirely. The National Palace is an irregular building in plan with a main part on the front with three aisles perpendicular to the façade (Fig. 5). The building is also irregular in elevation, with heavy mass concentration at the level of the three domes that are located on the front part of the building (Fig. 6). It is the unrestricted motion of the central dome accompanied by the failure of its supporting structure that precipitated the failure of the structures supporting the two lateral smaller domes. The columns are very lightly reinforced with no confining reinforcement as can be seen from Fig. 7. A fact discovered after the failure of the structure is the advanced corrosion of the reinforcement in the oceanfront climate of Port-au-Prince. This corrosion might have been caused also by the use of sea sands (Fig. 8). In the early 1900s, reinforcing steel was obtained outside the country and the bars were usually smooth, with standard 180-degree hooks for anchorage. With the creation of a local steel mill in the early 70s, 300-MPa deformed bars became available.

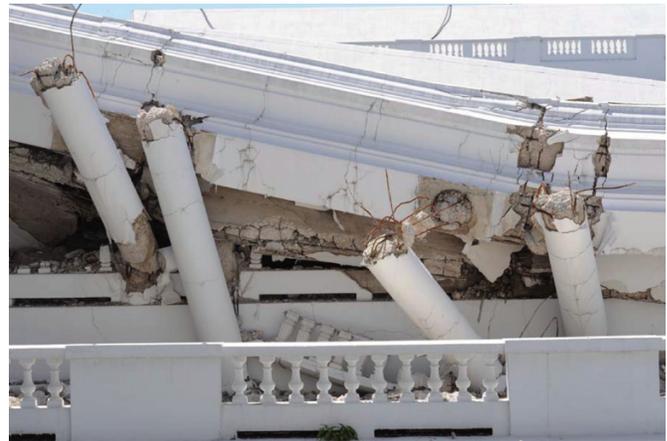
Fig. 7. Failure of lightly reinforced columns in the second story of the *Palais National* (note the absence of transverse reinforcement).

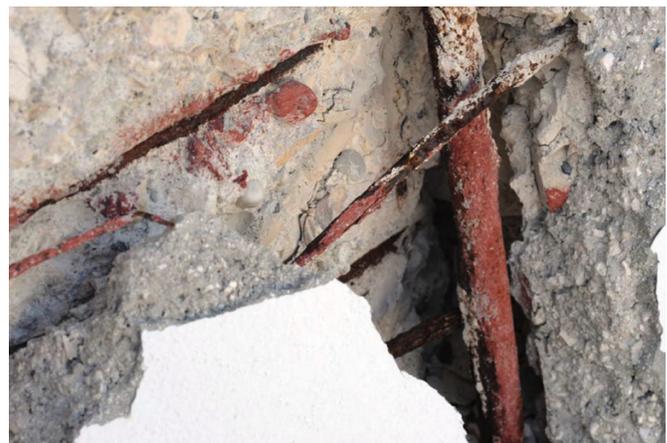
Fig. 8. Advanced corrosion of reinforcement in RC walls in the *Palais National*.

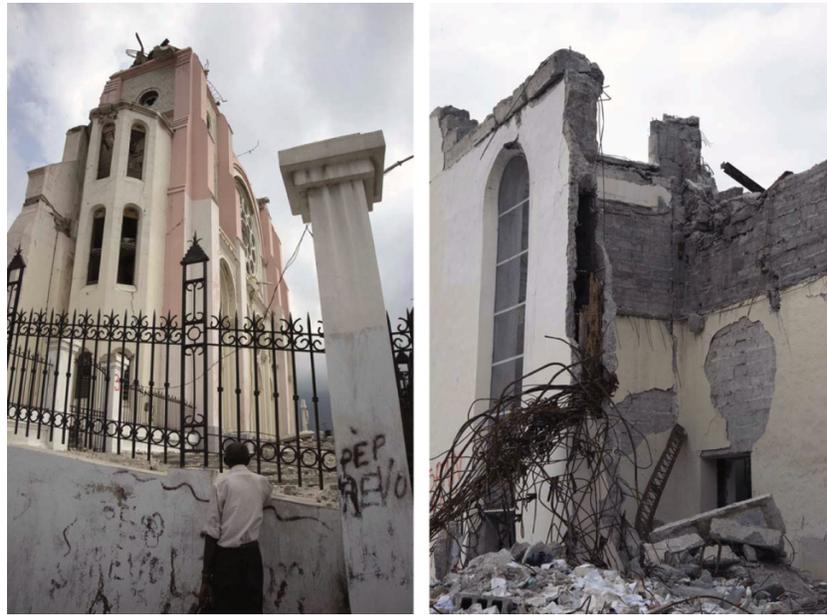
Fig. 9. The Port-au-Prince Cathedral with RC wall details.

Most of the major churches were built in the early 20th century. The most notable one is the Port-au-Prince Cathedral for which construction started in 1883 and was completed in 1912 by the Belgian firm of Perraud & Dumas. The cathedral is an unusual structure for the time, with reinforced concrete walls patented by this firm (Fig. 9). It completely collapsed during the earthquake. Another notable failure is the Christ Roi church, completed in 1908, which is a combination of reinforced concrete and masonry brick walls (Fig. 10).

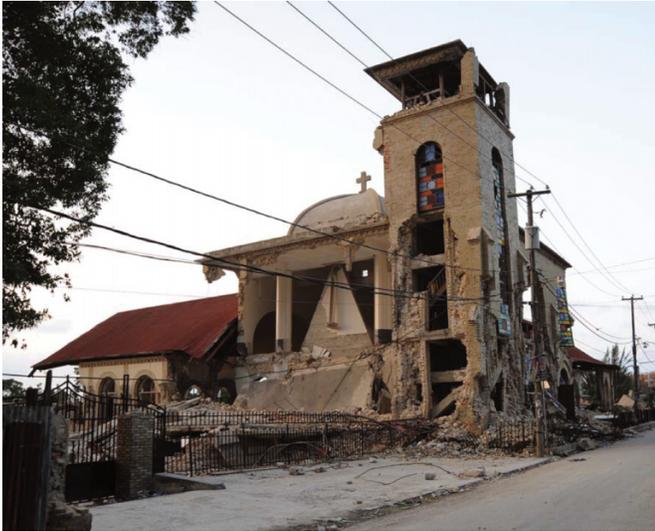
Fig. 10. Failure of the Christ Roi church.

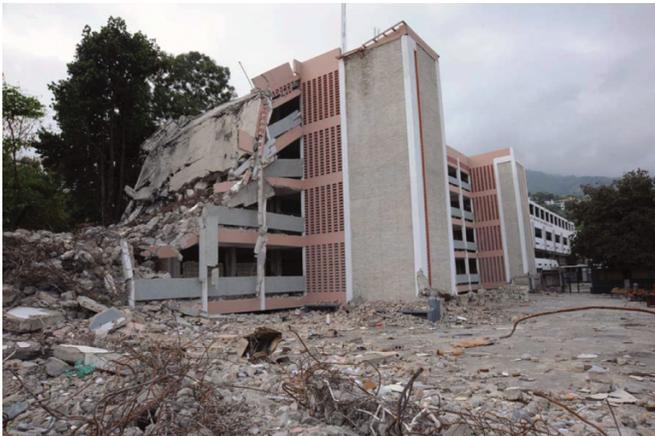
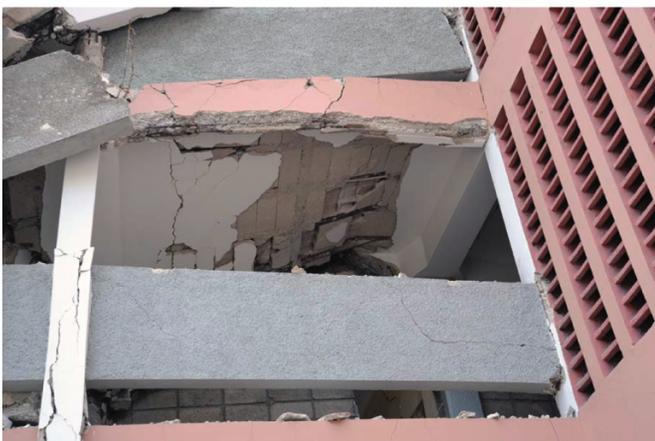
Fig. 11. Failure of the Canado-Haitien College. The bottom photo shows a *hourdis* slab failure.

It is estimated that 55% of all schools were destroyed or rendered irrecoverable. More than 38000 students, 1350 professors and 150 public servants in the education sector lost their lives in the West department that includes Port-au-Prince. This should never happen and measures should be taken immediately to correct the problem. Figure 11 shows the failure (crushing) of the first story of the Canado-Haïtien College (high-school). The failure of the first floor was precipitated by the soft/weak moment resisting frame with long spans. This configuration was necessary to accommodate a laboratory and an auditorium, while the top floors had stronger moment frames with infill hollow concrete block partition walls to separate classrooms. The building next door, which can be seen in the background in Fig. 11 and is also part of the college complex, suffered repairable damage. This other building had the same type of moment frames and partition walls on all floors, without a first soft/weak story.

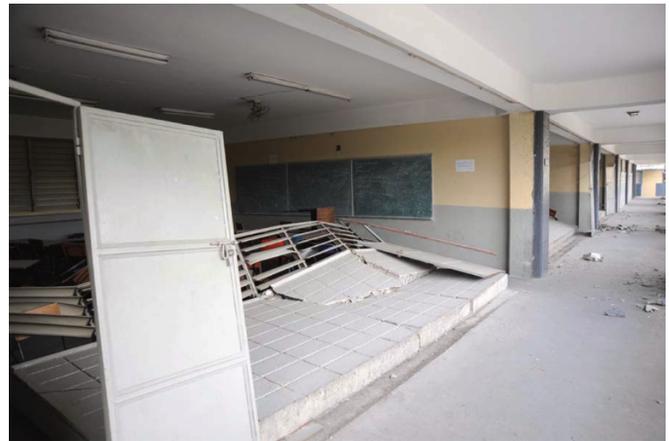
Fig. 12. Toppling of the hollow block concrete partition walls in the Canado-Haitien College.

Figure 12 shows classrooms in the second building, where the toppling of all the unreinforced partition hollow concrete block walls can be noticed along the corridor crushing the student desks. This type of failure has been observed in a number of schools in the Port-au-Prince area and clearly demonstrates that ducking under the desks as taught to the students in case of an earthquake is not always the safest action to take. Figure 13 shows another soft/weak story failure in the École Hôtelière in Port-au-Prince. The bottom picture clearly shows the insufficient longitudinal reinforcement and the absence of transverse reinforcement in the first story columns. Figure 14 shows the failure of the Villa Manrèse convent, also with crushing of the soft/weak first story

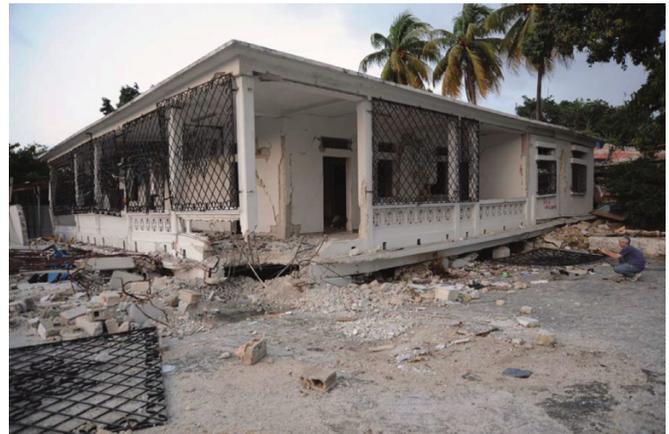
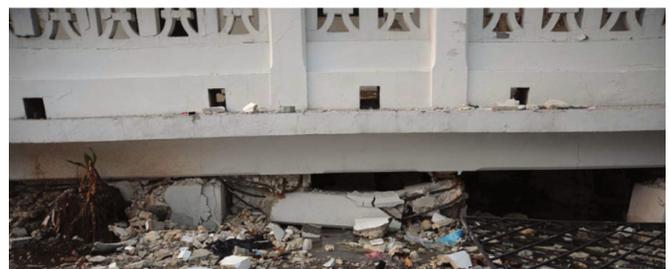
Fig. 13. Soft/weak failure of the École Hôtelière in Port-au-Prince (bottom picture shows a crushed column with little longitudinal reinforcement and no transverse reinforcement).

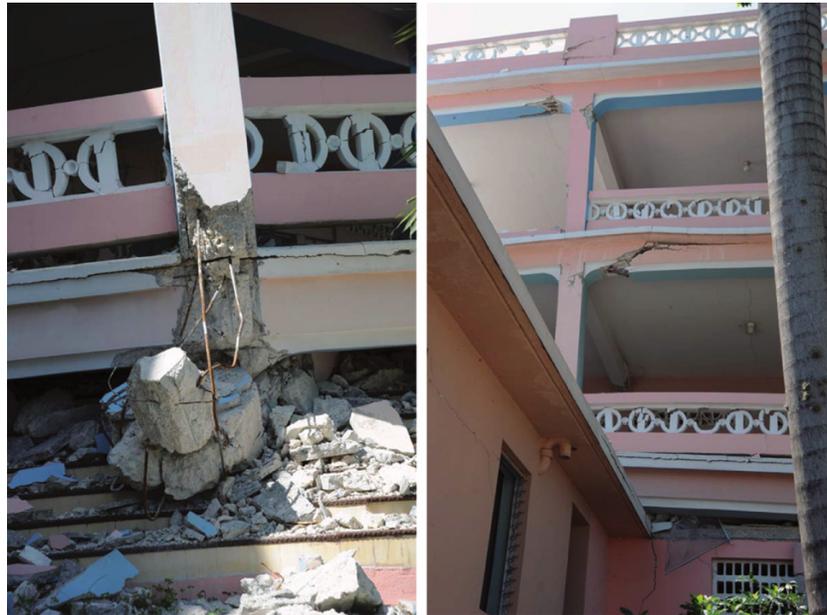
Fig. 14. Failure of the Villa Manrese convent. Left photo shows crushing of the first soft/weak story. Right photo shows relocation of plastic hinges in beams with haunches and damage in a weak column.

and relocation of plastic hinges in the beams with haunches. This soft/weak story problem was found to be one of the main causes of failures during this earthquake.

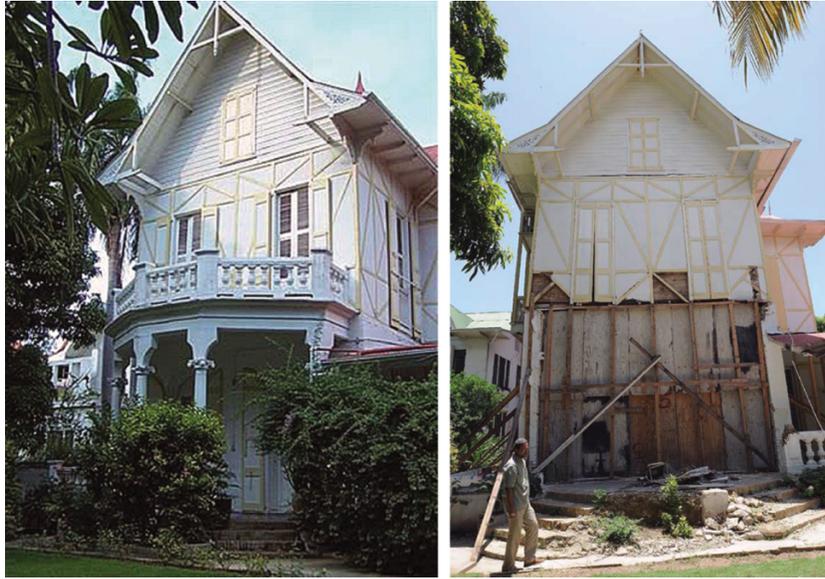
Fig. 15. Failure of the front reinforced concrete porch of the Mathon gingerbread-style residence.

Most gingerbread houses performed relatively well in spite of pre-earthquake damage due to years of neglect, termites attacks and questionable additions (that change the stiffness and regularity) to the original structures. Figure 15 shows a family house with damage that was caused by the collapse of the heavy reinforced concrete porch that dates to the construction of the house and can be seen in on the left in Fig. 15. This type of timber framing (*colombage*) is very efficient in resisting earthquake forces, as can be seen from this example.

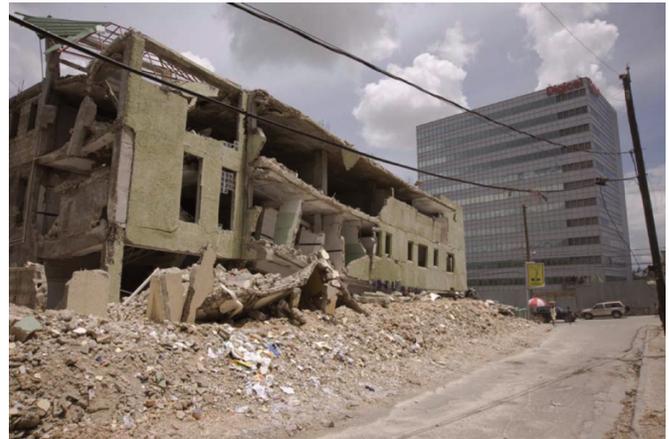
Figure 16 is a striking illustration of the behavior of two recent buildings that were completed at about the same time, shortly before the earthquake, at the end of 2009. The collapsed building in the foreground is the Turgeau hospital. It is a private hospital which was apparently design without consideration for seismic forces. The structure was realized partly with flat slabs supported by columns and infill walls, which is known to be inefficient for earthquake resistance. Just across the street from the hospital, is the Digicel building which survived the earthquake with almost no damage visible from the exterior. Figure 17 shows the Canapé Vert hospital which suffered little damage and was operational after the earthquake. It was located in the heavily-damaged Canapé Vert area, but performed quite well due to a better detailed strong moment-resisting frame.

Fig. 16. Complete collapse of the recently built Turgeau Hospital in the foreground, with the 12-storey frame-wall Digicel building in the background.

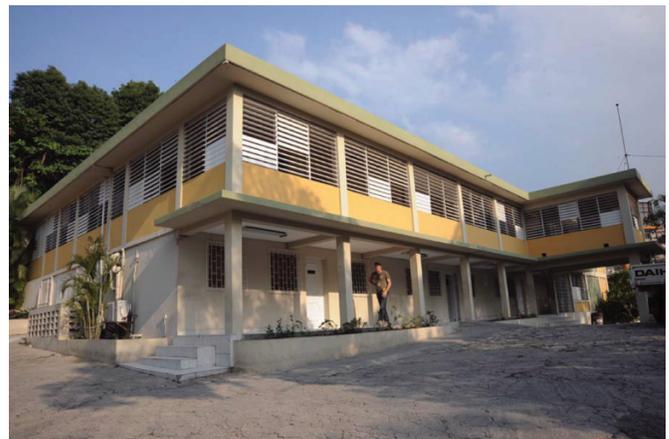
Fig. 17. The lightly-damaged Canapé Vert hospital.

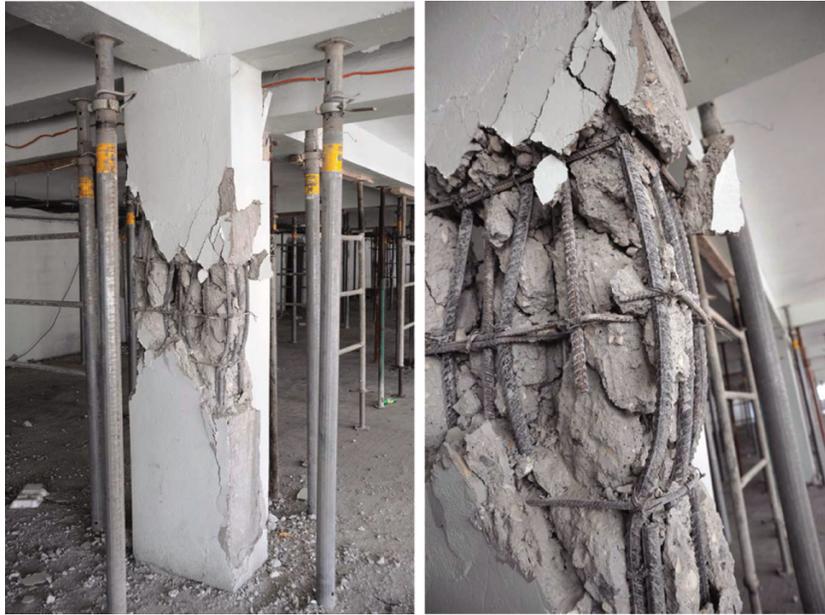
Fig. 18. Shear failure of columns in the parking garage of the Digicel building (note the 90-degree hooks in right photo).

them and the main 12 storey frame-wall building; (ii) to deficient reinforcement detailing (for example, hoops with 90° hooks, see Fig. 18); and (iii) to the presence of short columns created by partial height hollow concrete block walls. The most important point however was the significant, although repairable, damage that the beams and columns of the 12 storey frame-wall structure suffered in the top five storeys (Fig. 19 and Fig. 20). Damage to the columns can be attributed to the poor quality of the concrete. Concrete segregation was determined as the problem from the initial visual inspection at the time. Subsequent investigation by the structural engineers responsible for the building repairs determined that only the cover concrete had experienced spalling. The core column concrete was intact and proved very resistant to chipping by mechanical chisel when it was scabbled one inch behind the steel reinforcement as part of the structural repairs. However, significant damage to the beams connected to the walls is due the rotation demands imposed by the walls. The causes of this damage are discussed by Boulanger et al. (2013a, 2013b) and serve as a reminder that the design of the gravity load system in a well-designed structure with a clearly defined seismic force resisting system is an important task required by the NBCC, but often neglected.

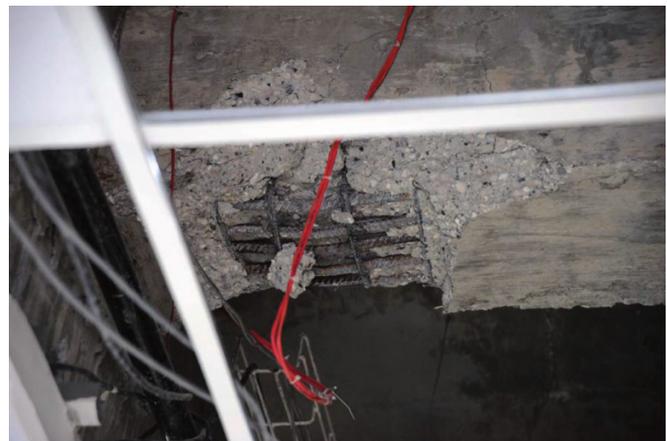
Fig. 19. Damaged beam in the Digicel building at wall connection.

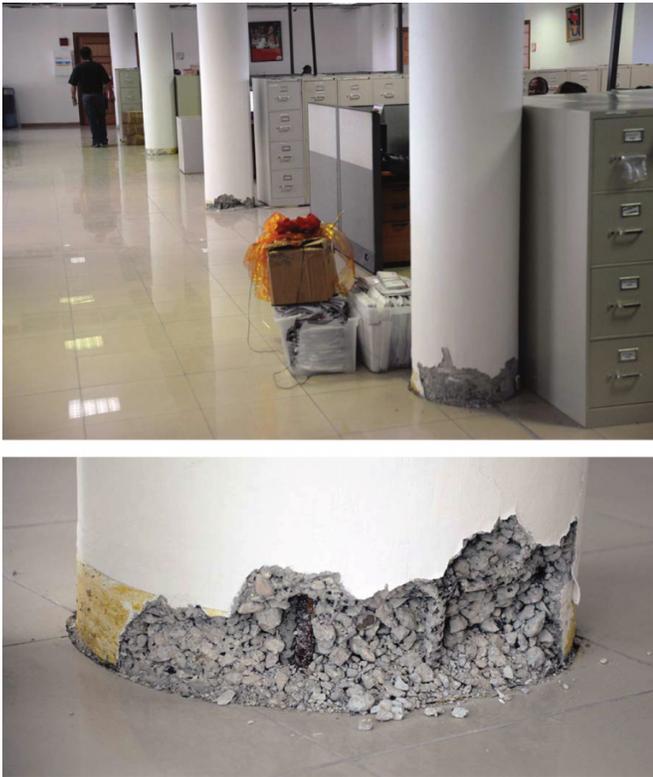
Fig. 20. Damage to the bottom of the columns in the upper five floors of the Digicel building.

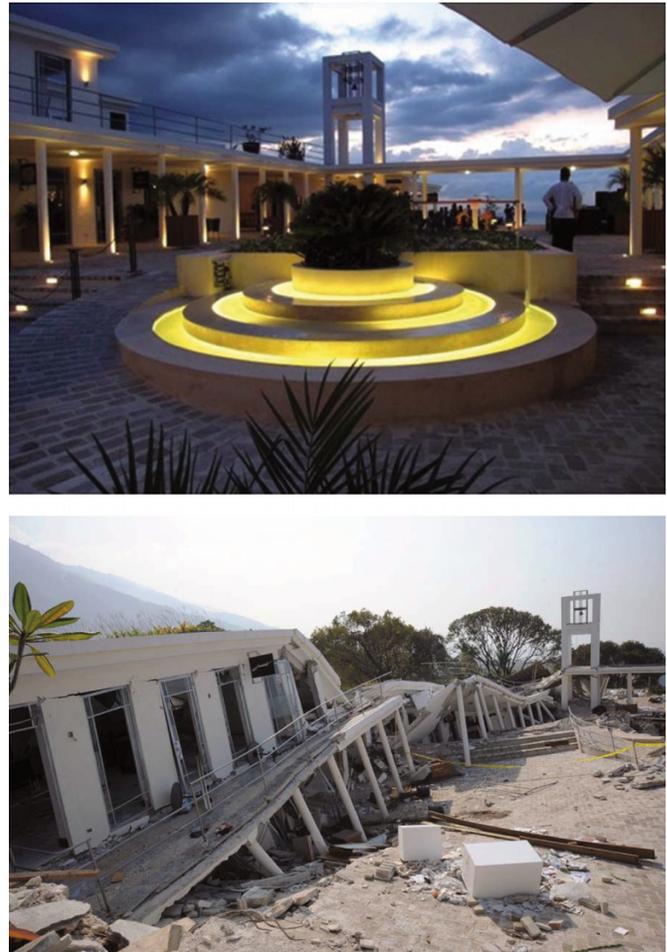
One of the most reported collapse resulting from the earthquake was the Montana Hotel. This luxury hotel was located on a hilltop in the Bourdon area of Port-Au-Prince. Figure 21 shows a portion of the collapsed hotel. It was apparent that the effective cross-section of the columns were much too small (partly covered by thick cement grout), with a very low amount of longitudinal reinforcement, and almost no transverse reinforcement. In addition, this hotel was located in a region of the city where the topography seems to have played a role. Concentration of damaged buildings in a band along the foothill ridge where the hotel is located pointed to possible topographic amplification. Hough et al (2010) and Assimaki and Jeong (2011) reported significant amplification in this zone from the analysis of aftershock recordings. The extensive damage observed at the Montana is therefore probably a combination of poor engineering as well as local seismic motion amplification.

Fig. 21. View of the shopping mall on top of a parking structure of the Montana Hotel. Top photo before the earthquake (source: Internet) and, bottom photo, damage after the earthquake.
