The El Salvador Earthquakes of January and February 2001: Context, characteristics and implications for seismic risk

ABSTRACT

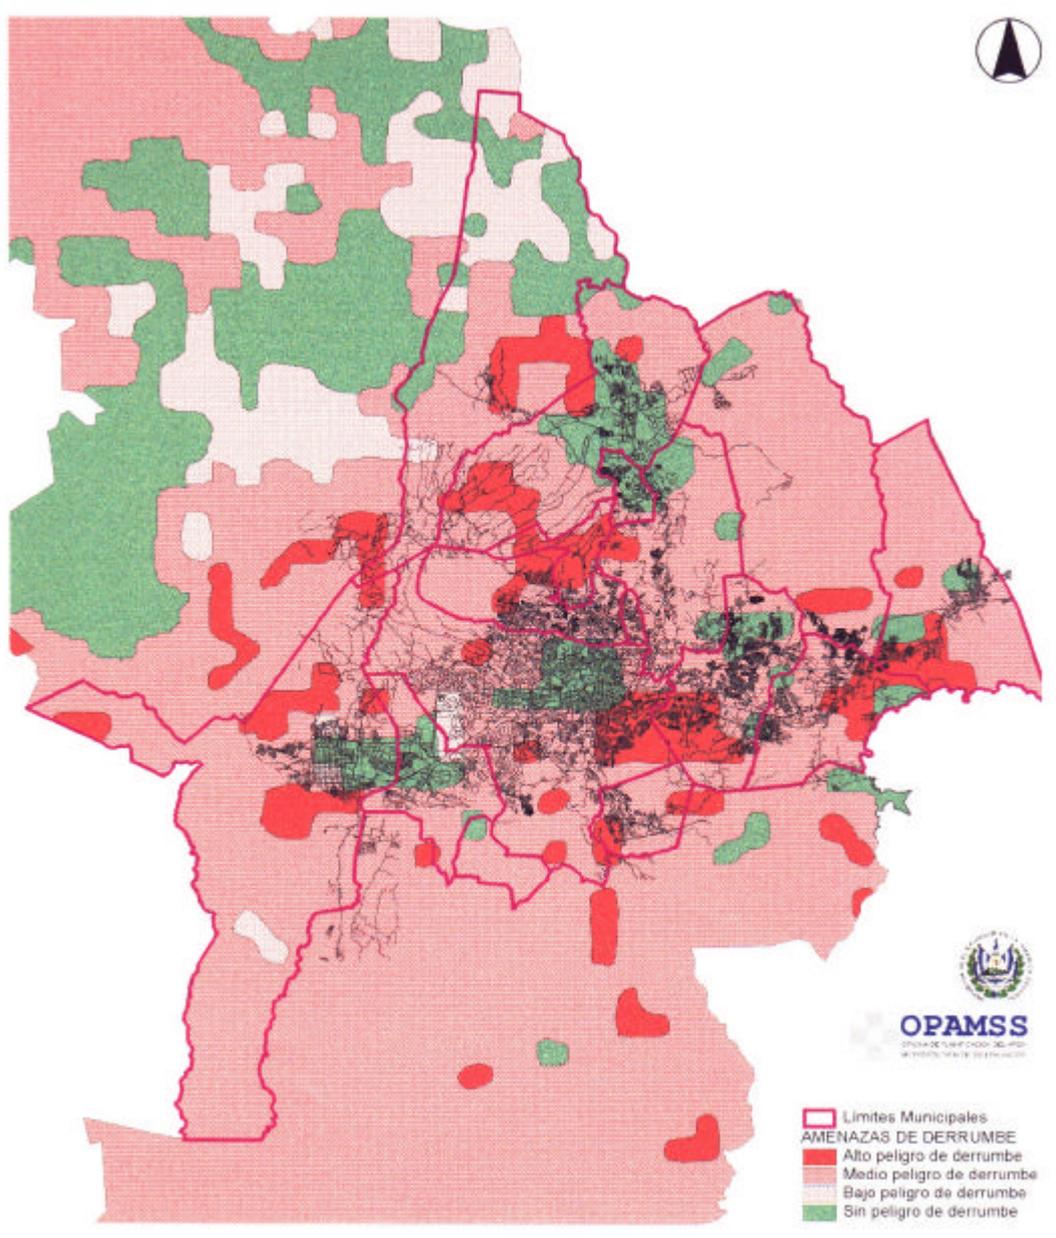
Figure 3 shows a landslide hazard map prepared by the Planning Office for the Metropolitan Area of San Salvador (OPAMSS) as part of PLAMADUR in 1997. The map identifies a most of the metropolitan area of the capital as being of medium landslide hazard with several areas highlighted, in dark red, as being of high hazard: amongst these is the area affected by the catastrophic landslide at Las Colinas (Section 5.1).

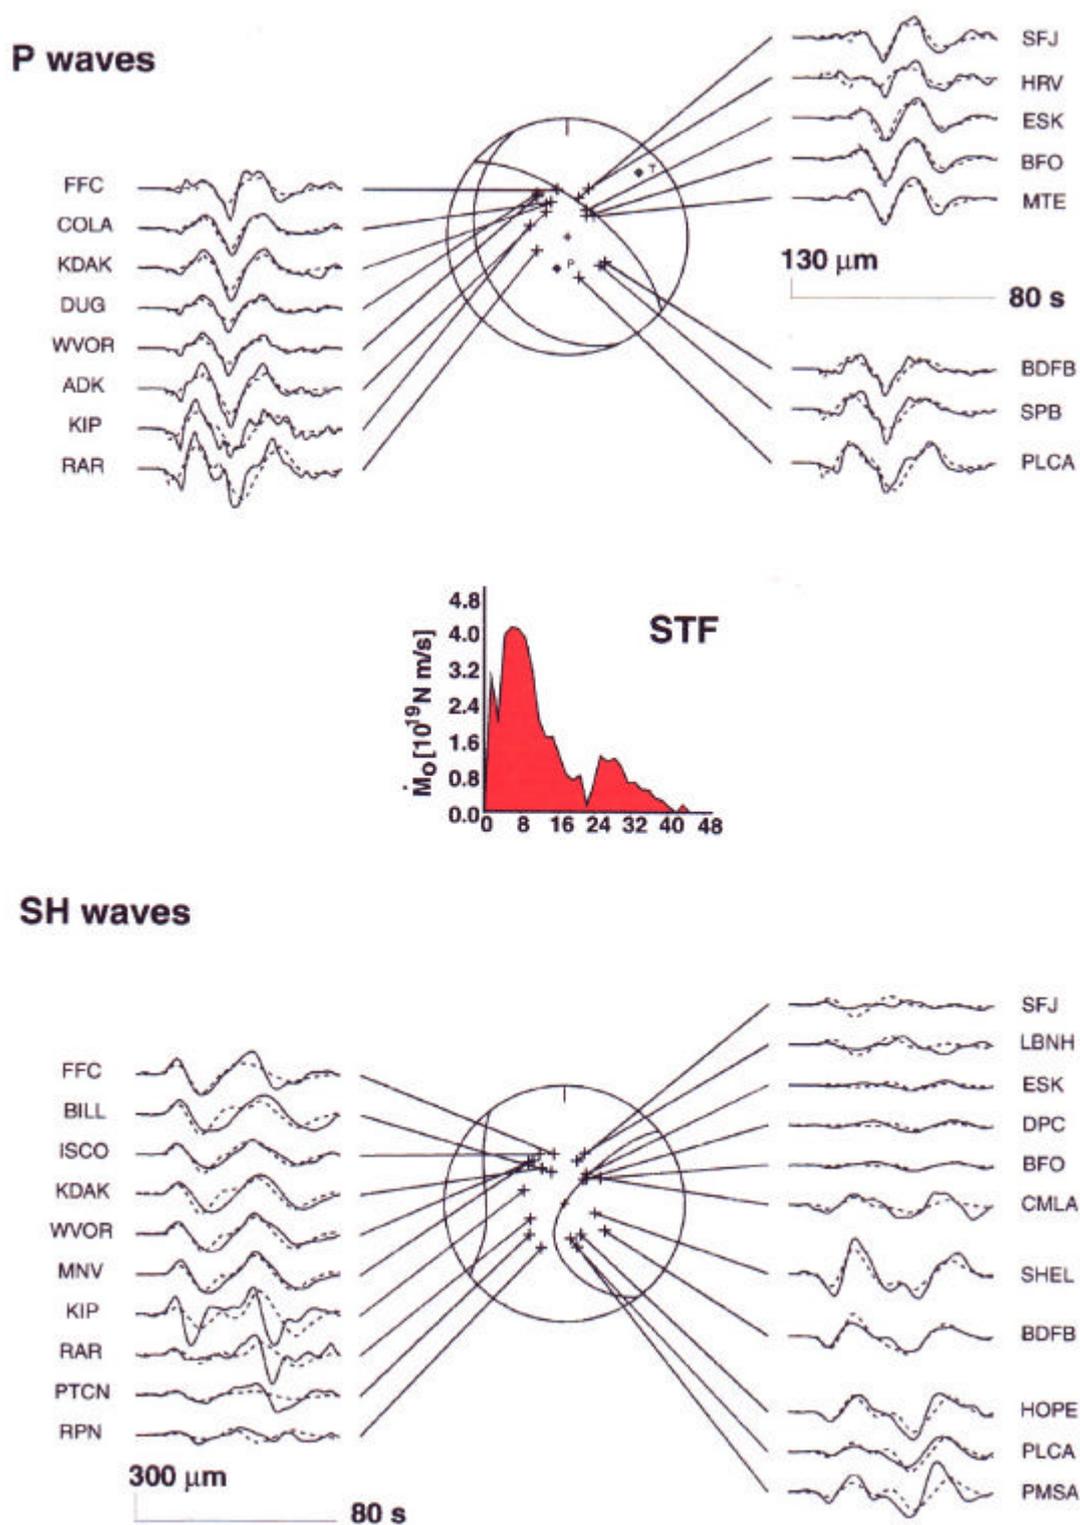
Figure 4 shows body-waveform inversion results for the earthquake of January 13. Solid lines are observed displacement and dotted lines are synthetics. For this event, P waves were relatively well fitted by our simple point source model. For P- and S-waves the first arrivals were not very well modelled because the S-waves – which are much stronger – dominate the inversion. The strong SH arrivals force the source time function of the earthquake to start with a very strong impulse. The peak appears to be much weaker for P-waves. The depth we found was 50 km. The more vertical fault plane were well constrained by the azimuthal coverage. The source time function can be divided into two sub-events: the first one had higher amplitude and a duration of 22 seconds; the second sub-event occurred during 24 seconds. The seismic moment was 5.54×10^{20} Nm. It is difficult to observe any directivity effect. However, if we compare signals from LBNH and KIP stations with their synthetics (which were modelled with a point source), we observe a possible directivity effect. If we assume that the fault plane is the sub-vertical one, as is commonly observed for intraplate events, there could be an upward rupture propagation (Figure 4); more data is required in order to constrain this directivity. The M_w 7.7 earthquake of 13 January 2001 was an intermediate depth earthquake that occurred inside the down-going Cocos plate. Its tension axis was sub-parallel to the dip direction of the descending slab.

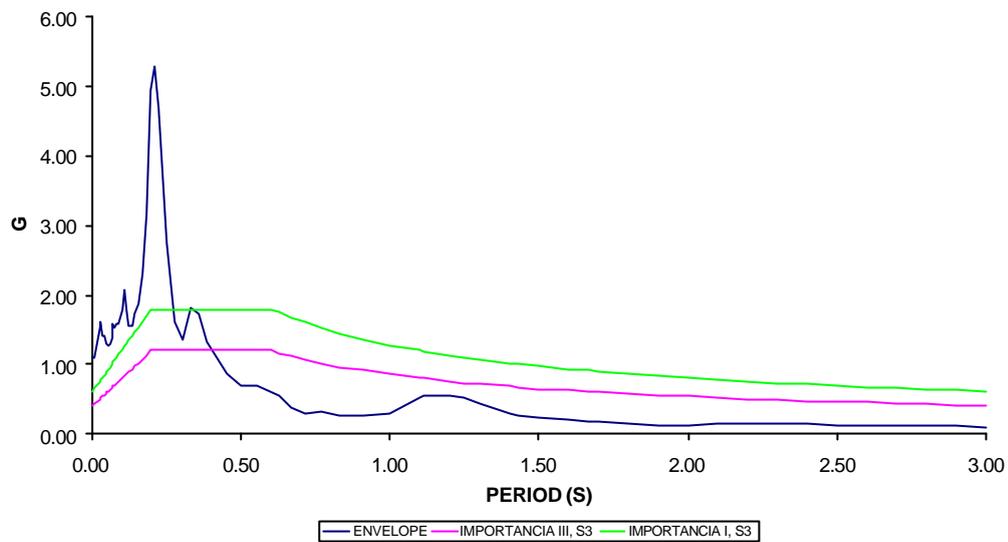
Figure 12

LA LIBERTAD. JANUARY 13TH, 2001.

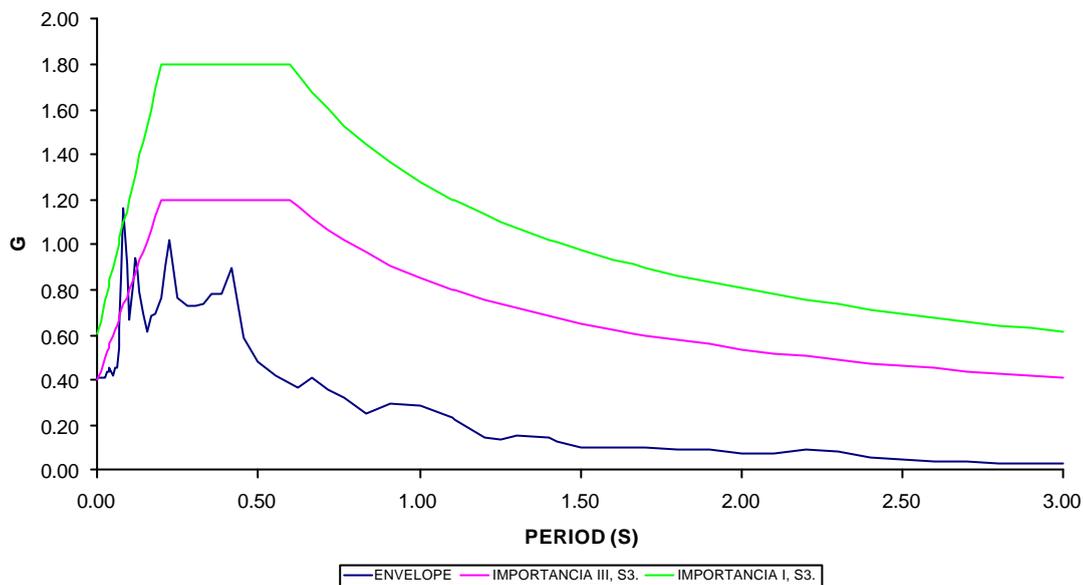
Figure 13a

ZACATECOLUCA. FEBRUARY 13TH, 2001.

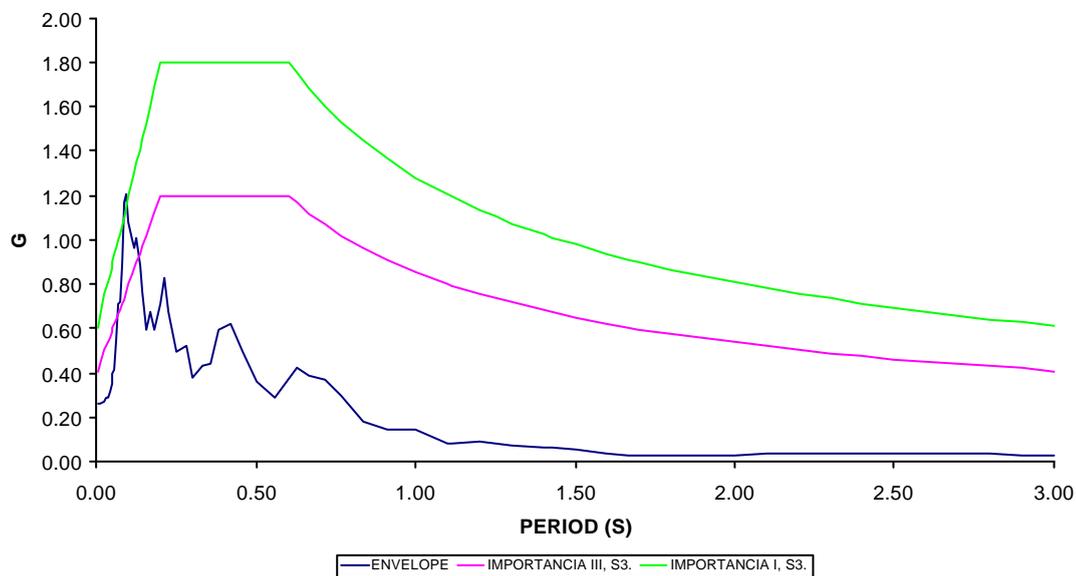
Figure 13b

ZACATECOLUCA. JANUARY 13TH, 2001.

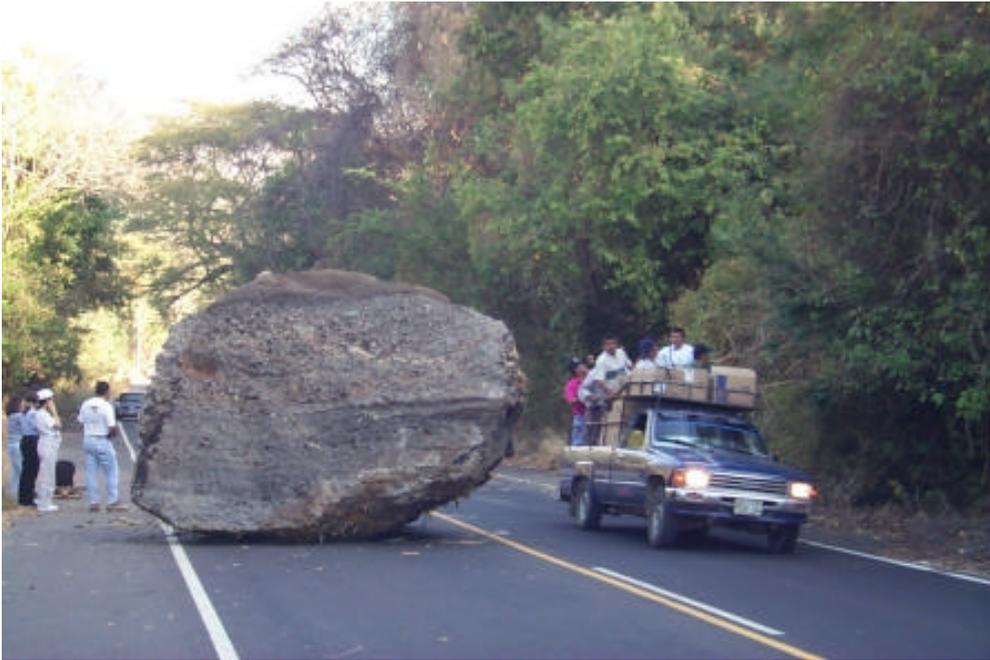
Figure 14

Rockfalls and debris falls were common throughout the area and ranged from single block falls (some of which were up to 3 m in diameter, Figure 14) to the collapse of slopes cut in pyroclastic ashfall deposits, which exist as a result of weak cementation and high negative pore pressure (Bommer *et al.*, 1998a; 2002). Such failures were largely independent of lithology, but occurred only on steep slopes. Individual block falls were more common in the rocks of the Balsamo Formation because of the prevalence of persistent discontinuities in the form of bedding and cooling joints. Highly altered layers of volcanic rock also acted as aquitards.

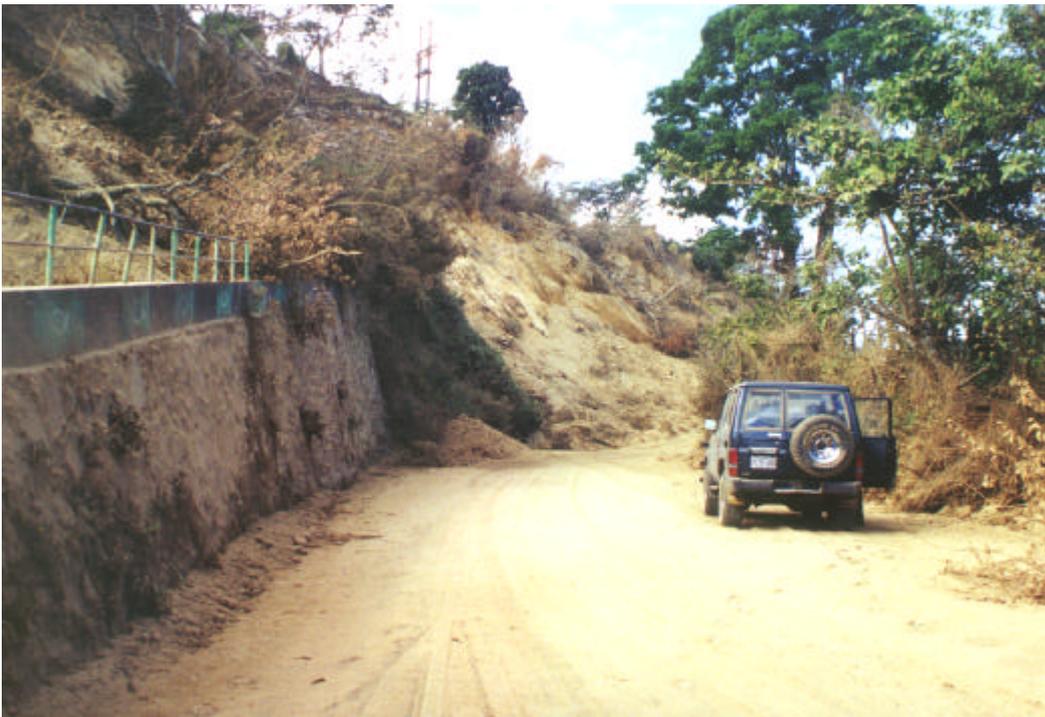
- Figure 14 Single block fall, triggered by an aftershock of the 13 January earthquake, on the coastal motorway near La Libertad.
- Figure 15 Debris fall from the Tierra Blanca near Comasagua.

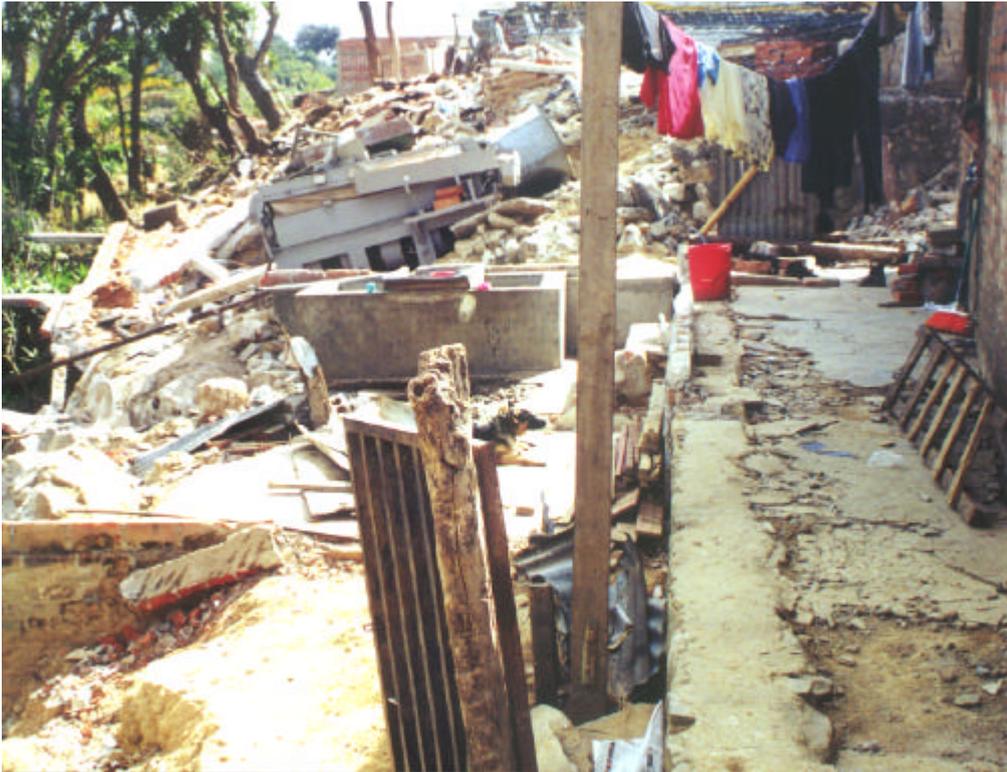
Figure 15

The occurrence of rock and debris falls in the Tierra Blanca affected an extensive area around the Comosagua Road on the Balsamo Ridge. Here the steep slopes which were formed to allow the road to but failed in spectacular manner giving rise to an extensive area of slope instability which extended from the landslide at Las Barrioleras to the Jayaque-Comosagua Junction (Figure 15) and in Comasagua itself (Figure 16). This formed a classic shattered ridge. In many cases, it was impossible to tell where one landslide ended and another began.

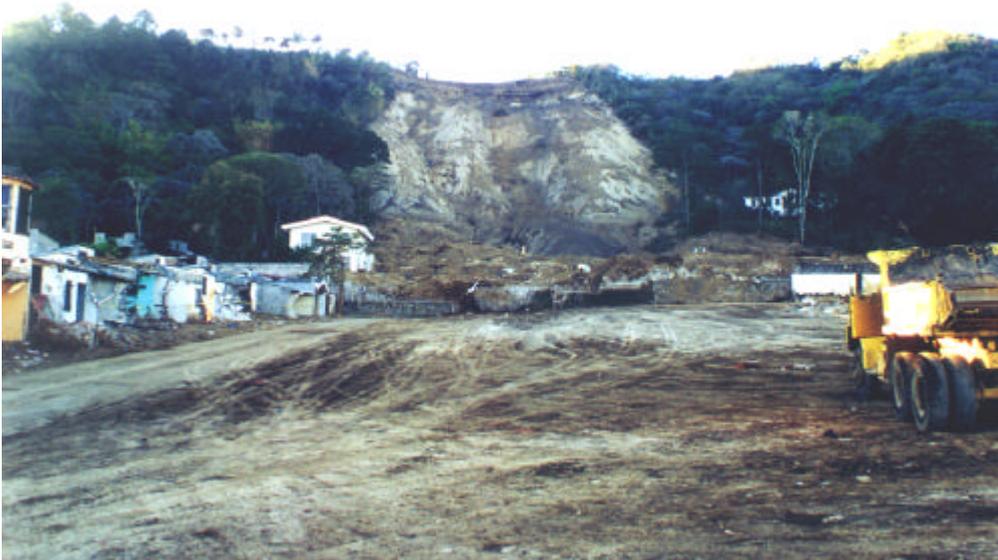
- Figure 16 Landslide damage in Comasagua.
- Figure 17 The Las Colinas landslide, Santa Tecla.
- Figure 18 Distribution of areas affected by landslides (solid line), by concentrated landslides (small dashes) and by liquefaction (large dashes).

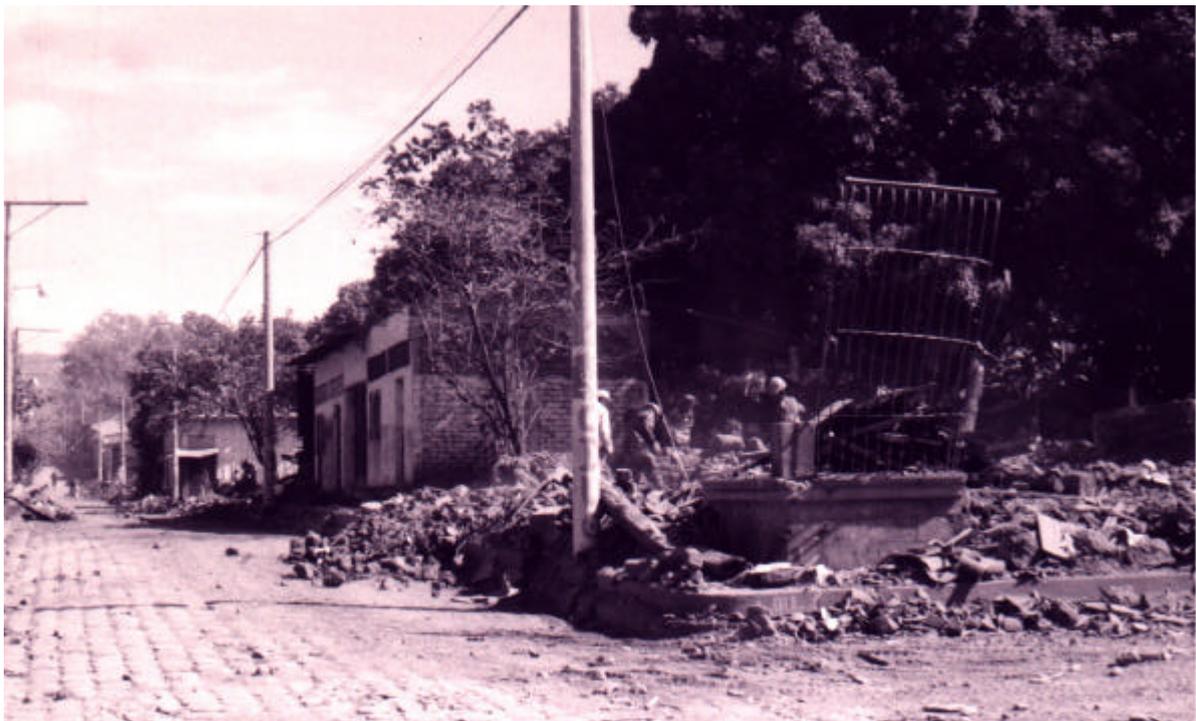
The damage patterns clearly revealed the social vulnerability of poor forced to live in susceptible locations and vulnerable houses. Small towns such as San Agustín (Figure 20), where 80% of the houses were made from adobe, were particularly hard hit. The same pattern was visible in small hamlets and villages, where adobe was even more dominant and where the quality of construction was generally poor. Even in San Salvador, where damage was very limited and barely visible to the casual observer, we found extensive damage, due

- Figure 21 Collapsed *adobe* house in San Agustín, of which only the door remains standing after the 13 January earthquake; behind are houses of *mixto* and *lamina*, which have survived the earthquake.

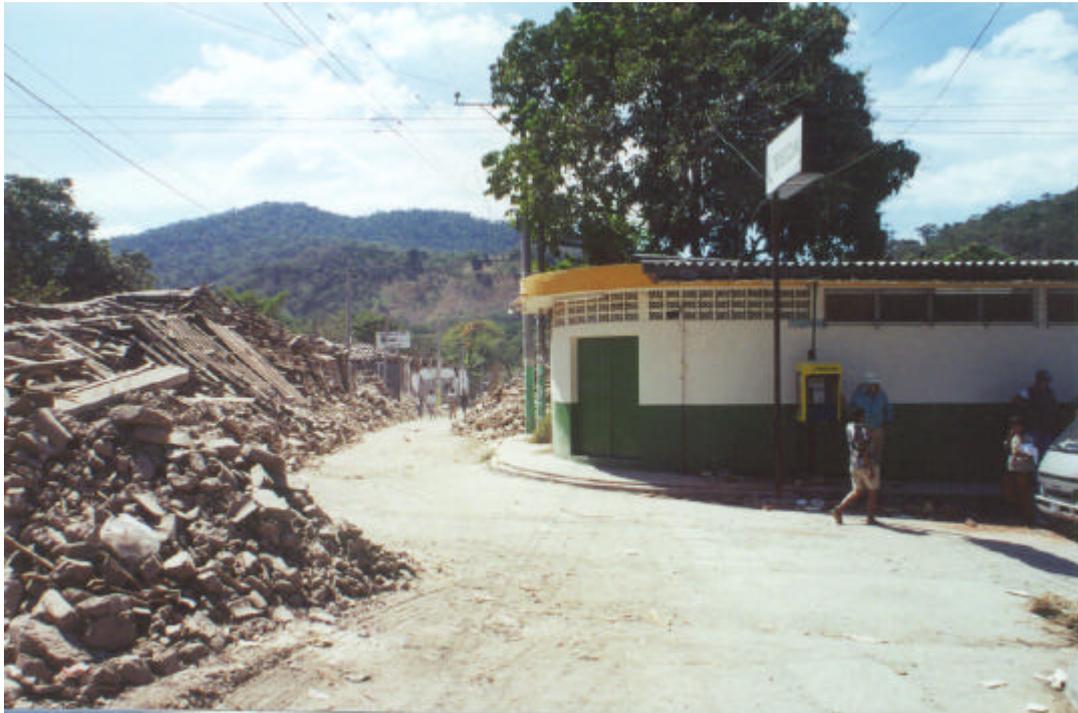
Figure 22.

- Figure 22 Guadalupe following the 13 February earthquake, contrasting total collapse of *adobe* houses with the almost undamaged state of the reinforced masonry building to the right.

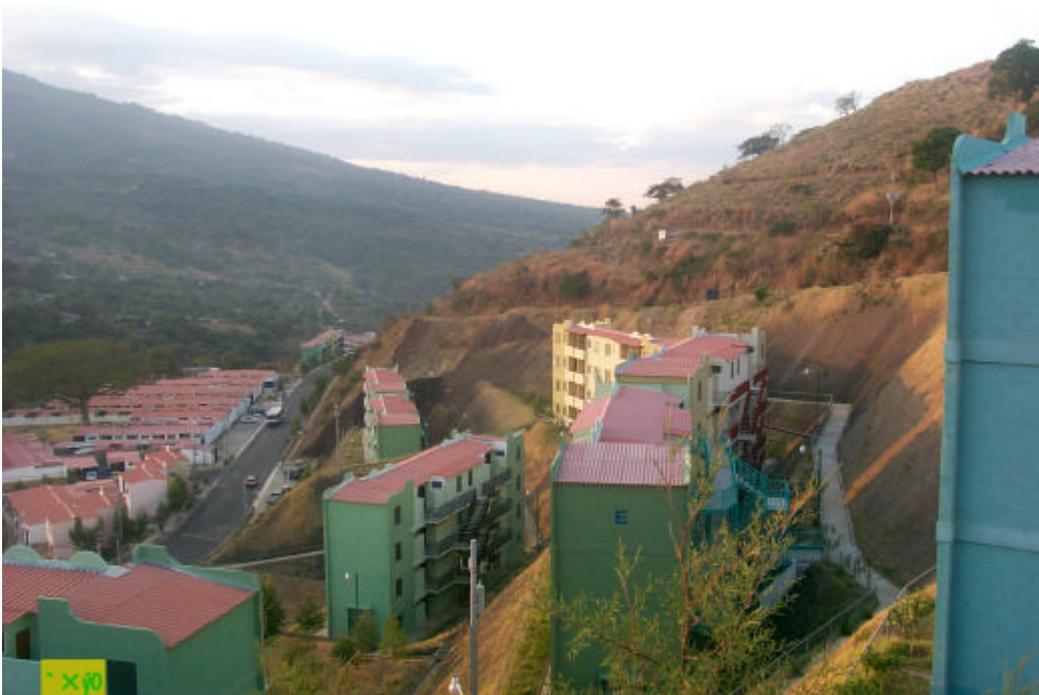
FIGURE 23a.

- Figure 23 Santísima Trinidad residential area north of San Salvador built on terraces along a steep slope (a) above which are three large water tanks (b).

The high level of landslide hazard in El Salvador makes land-use planning an issue of great importance. The high population density of El Salvador and the housing deficit also makes it a sensitive and controversial issue. There is currently almost no effective control over land development. It is interesting to note that the landslide hazard map shown in Figure 2 clearly indicates that the area affected by the catastrophic landslide at Las Colinas was identified as being of high hazard. The hazard map was prepared some years after Las Colinas was developed in 1985, but nonetheless no remedial action was taken to stabilise the slopes or to protect the area from landslides. The irrelevance of geohazards in planning decisions is very clearly demonstrated by a recent housing development to the north of San Salvador, called Santísima Trinidad (Figure 23). The development consists of several rows of four-storey
