Damage to engineered structures during the 12 January 2010, Haiti (Léogâne) earthquake¹

Patrick Paultre, Éric Calais, Jean Proulx, Claude Prépetit, and Steeve Ambroise

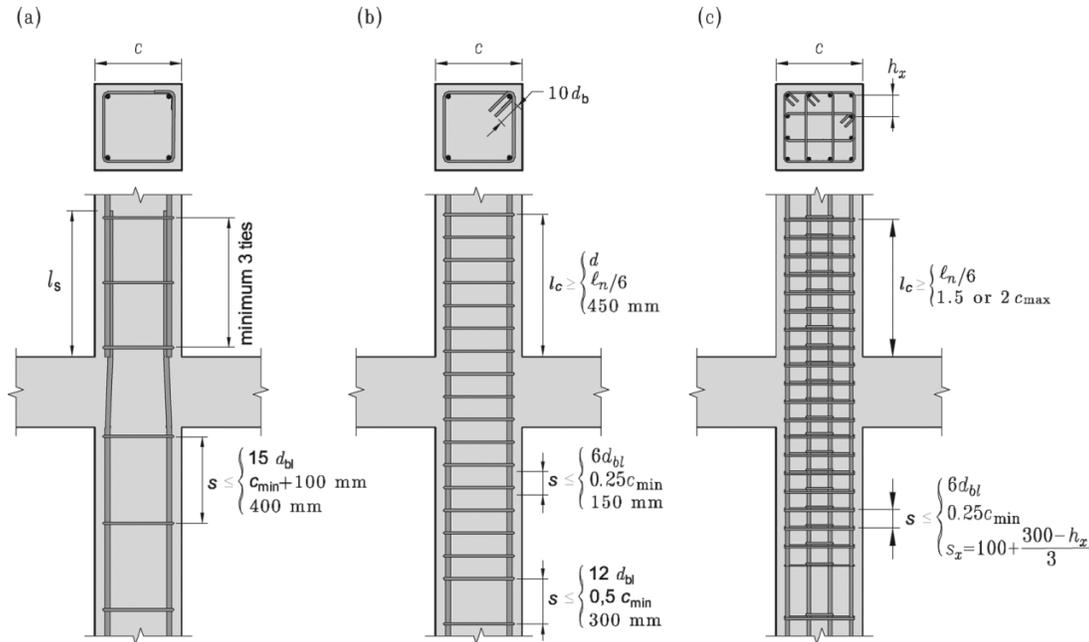
Fig. 2. Column's transverse reinforcement details from (a) BAEL 91, (b) AFPS 90 (1992), and (c) CSA A23.3-04 (2004).

Most engineered buildings are of the rigid frame type with unreinforced infill walls constructed with hollow concrete blocks and one or two-way concrete *hourdis* slabs. Surprisingly, non-engineered constructions and houses used confined masonry construction methods, whereas engineered buildings did not. Figure 2a shows a detail of the transverse reinforcement requirements in BAEL 91. It must be understood that before the adoption

of the Eurocode in France, two codes were in use: a code for general reinforced concrete construction (BAEL 91) and a code for seismic design of buildings in seismically active zones (AFPS 90). Seismic hooks and seismic hoops were defined in the AFPS code (Fig. 2b). This is why, for instance, 90° hooks were standard practice in Haiti, because only the general construction code was used. In addition, because of incremental construction, longitudinal

bars in columns were continued just above the joints with only three ties required over the lap splice length (Fig. 2a). This detailing is not allowed in the CSA A23.3 for seismic design (Fig. 2c). Generally, the beams are stronger and stiffer than the columns that have very small (200 to 300 mm²) cross sections. Figure 3 shows a three story building with a soft storey failure. Note the small dimensions of the corner columns (350 to 400 mm for the first story, and 200 mm for the upper storeys).

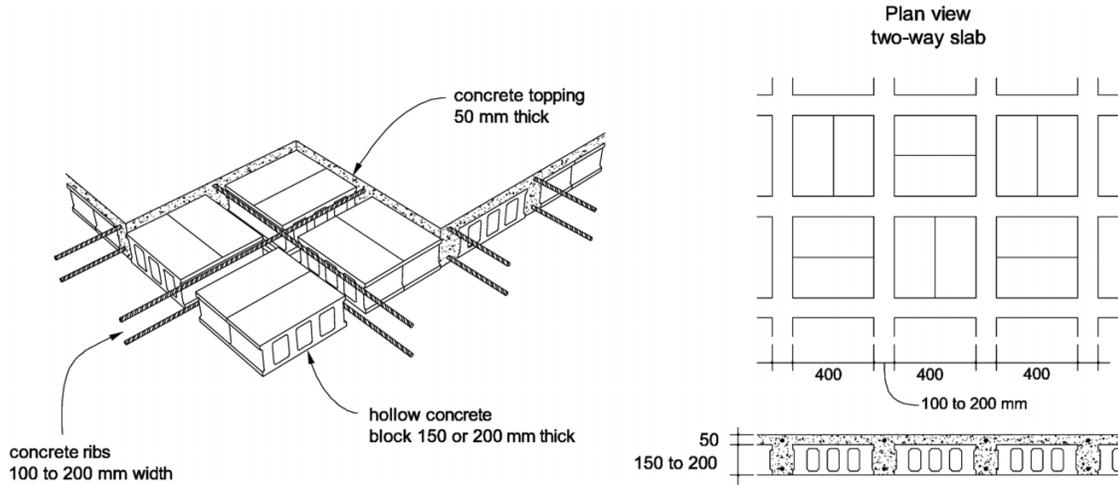
Fig. 4. Details of a hollow concrete block *hourdis*-type two-way slab system.

Two-way slabs, of the *hourdis* type, are used in 90% of floor construction in Haiti. They are built as shown in Fig. 4. In this system, widely used in South America, the Caribbean and Europe, hollow concrete blocks (150 or 200 mm thick) are used as fillers between 100 and 200 mm wide concrete ribs and are covered by a concrete topping (about 50 mm thick). Reinforcement bars are placed along the ribs in one direction or in both directions for

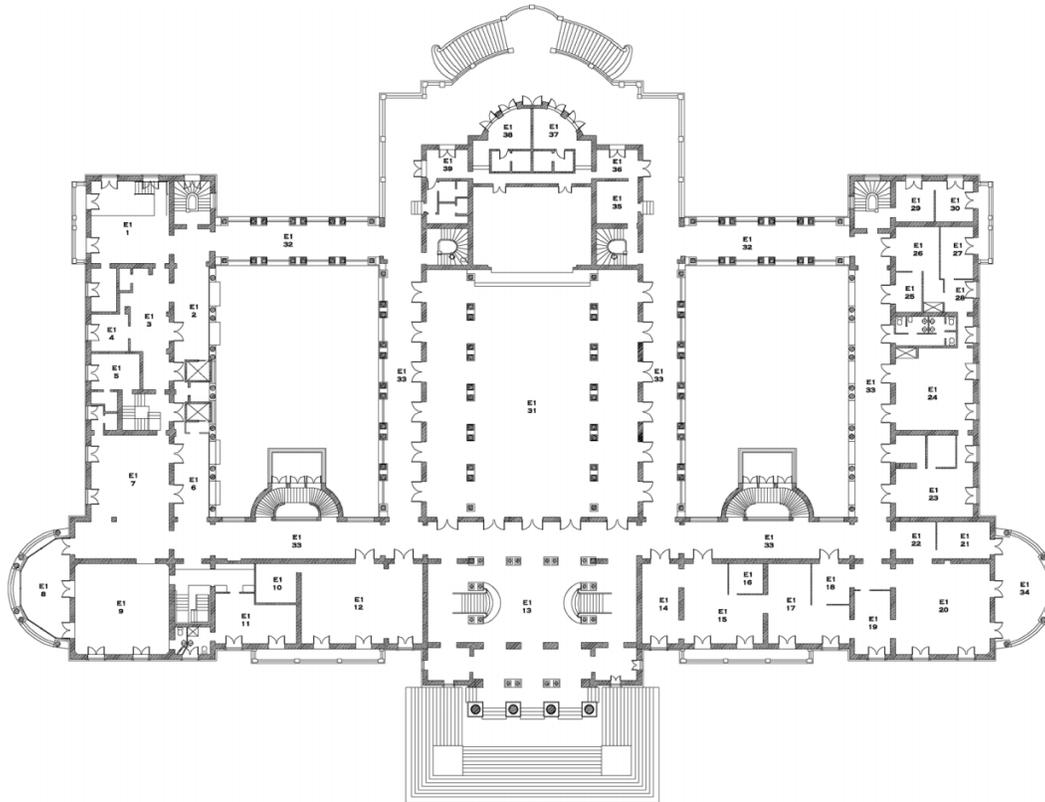
Fig. 5. Plan view of the Palais National, Port-au-Prince.

The *Palais National*, the presidential residence, is the most well-known landmark building in Port-Au-Prince. Built between 1913 and 1921, it was designed by Georges Baussan, one of the three architects that developed the gingerbread style houses in Port-Au-Prince. This building was designed by the French Hennebique firm in the early period of the development of reinforced concrete as a construction material. The reinforcement materials are surprisingly varied in form, due to the fact that the construction took place in part during the First World War and that the materials had to be purchased sometimes on the black market (Corvington et al. 2003). It is a moment-resisting frame system with infill unreinforced brick masonry, as well as infill rubble walls. Some infill walls are covered with what appear to be reinforced concrete walls that might have been added later and explained why the building did not collapse entirely. The National Palace is an irregular building in plan with a main part on the front with three aisles perpendicular to the façade (Fig. 5). The building is also irregular in elevation, with heavy mass concentration at the level of the three domes that are located on the front part of the building (Fig. 6). It is the unrestricted motion of the central dome accompanied by the failure of its supporting structure that precipitated the failure of the structures supporting the two lateral smaller domes. The columns are very lightly reinforced with no confining reinforcement as can be seen from Fig. 7. A fact discovered after the failure of the structure is the advanced corrosion of the reinforcement in the oceanfront climate of Port-au-Prince. This corrosion might have been caused also by the use of sea sands (Fig. 8). In the early 1900s, reinforcing steel was obtained outside the country and the bars were usually smooth, with standard 180-degree hooks for anchorage. With the creation of a local steel mill in the early 70s, 300-MPa deformed bars became available.
